## Warranty (Defect) inspection report

Warranty (Defect) inspection report

Type:	Domestic	Freestanding House
Bedrooms:	4	
Bathrooms:	2	
Ensuites:	1	
Car Park:	Triple	
Height:	Single Story	
Building:	Brick Veneer	
Piers:	Concrete	
Floor:	Timber with concrete areas	
Roof:	Metal	
Age:	New build

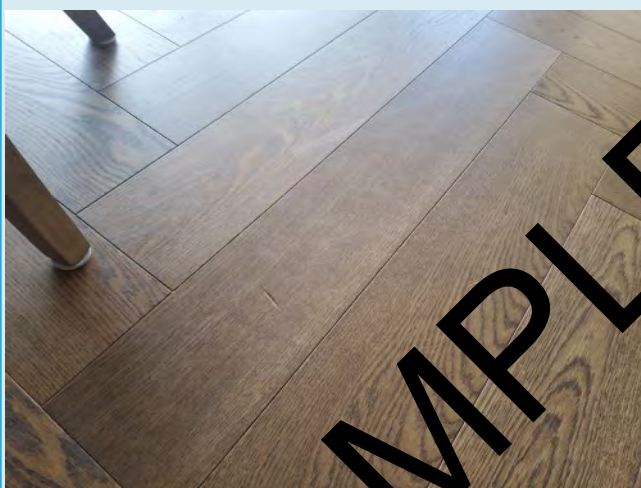
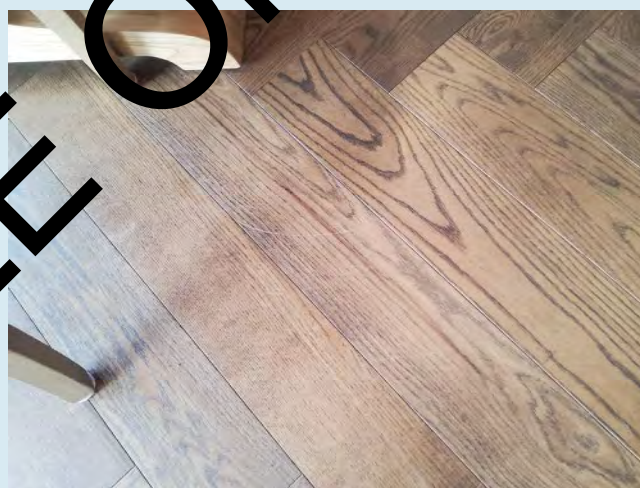
There are scratches, scrapes and discoloured surfaces in several areas, consistent with damage to surface coating of floor laminate timbers.  
Recommend resurfacing floor laminate with more durable hard-wearing surface coating that is fit for purpose.

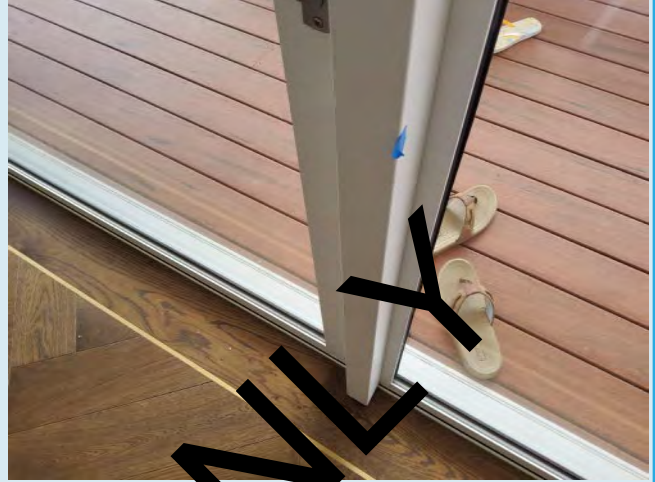
Dents and minor blemishes to framing around sliding doors and windows should be touched up to consistent finish.

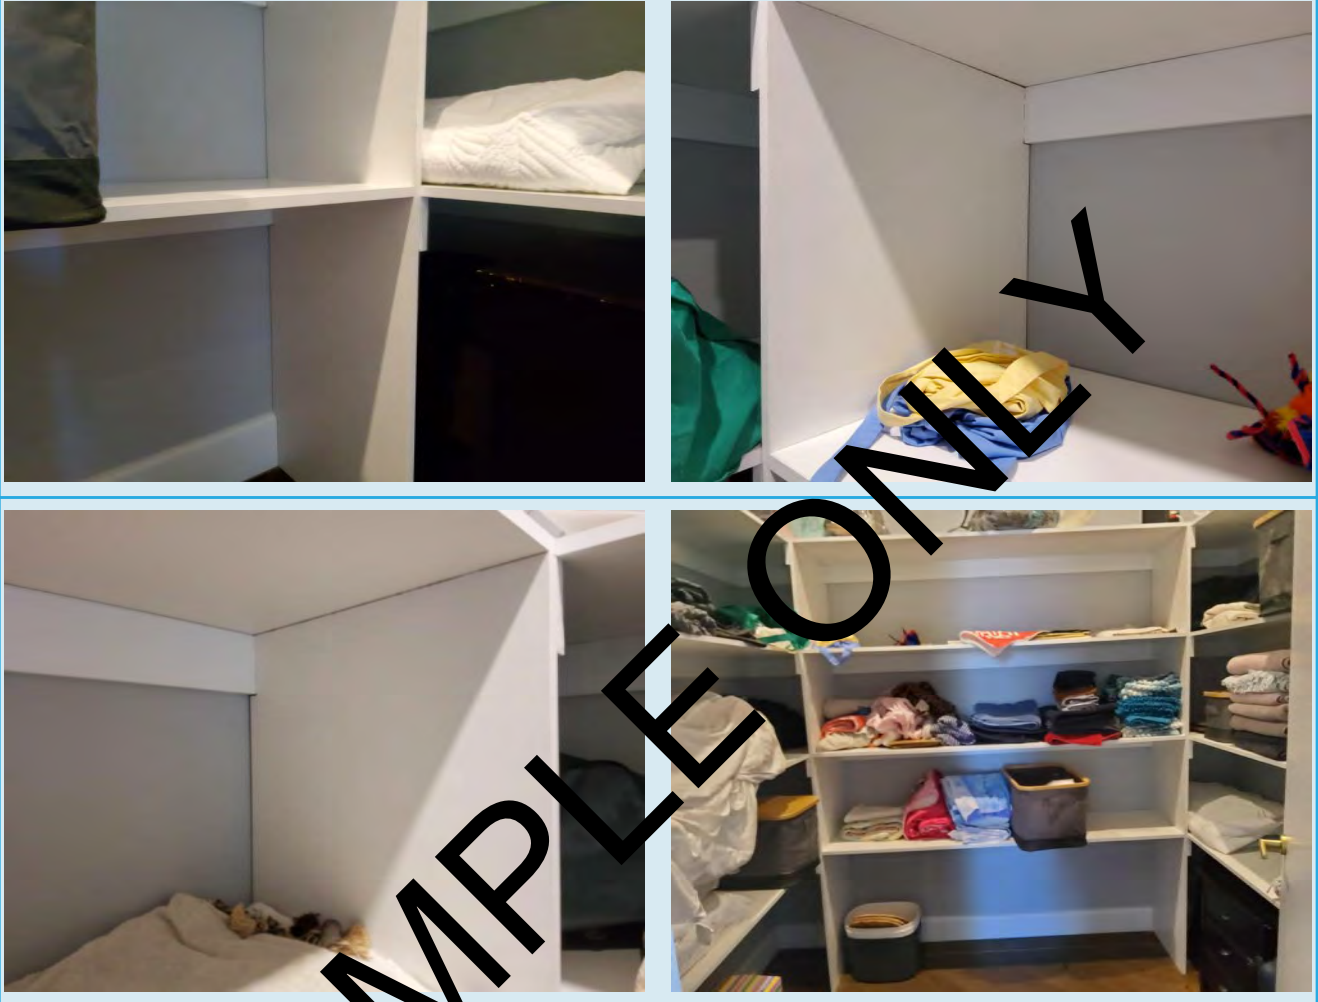
Linen cupboard cabinetry - seal gaps between fixed panels and walls.

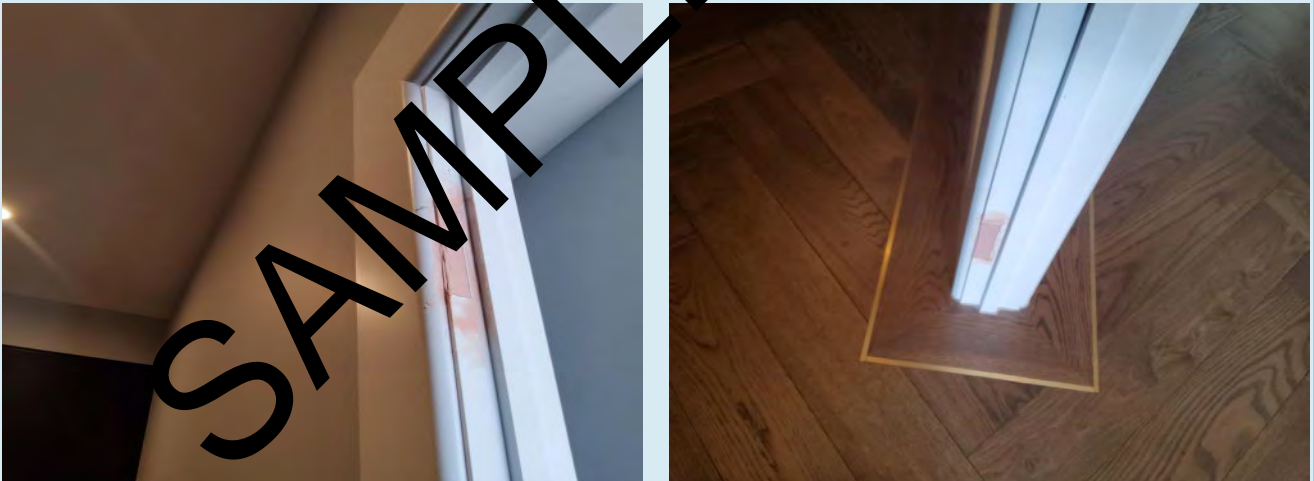
Kitchen	
Minor and/or Major Defect	Doors
Comments	
Make good butlers pantry doorjamb where hinges were removed, to a smooth painted finish.

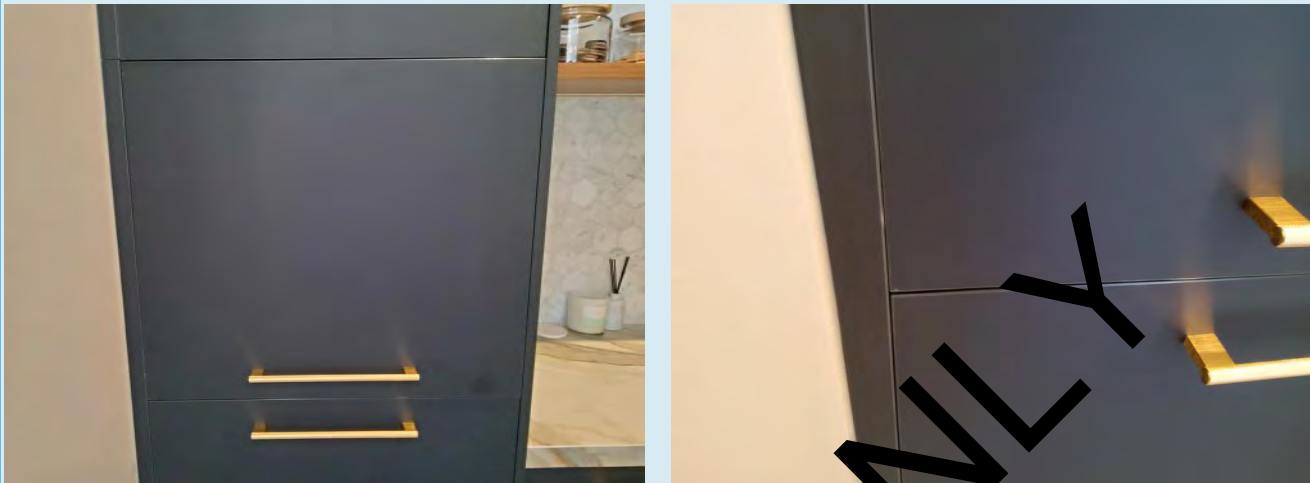
Kitchen	
Minor and/or Major Defect	Ground Cabinets
<b>Comments</b>	
Microwave cabinet door scrapes left side. Adjust the cabinet doors/drawers so there are consistent margins, and surfaces align.

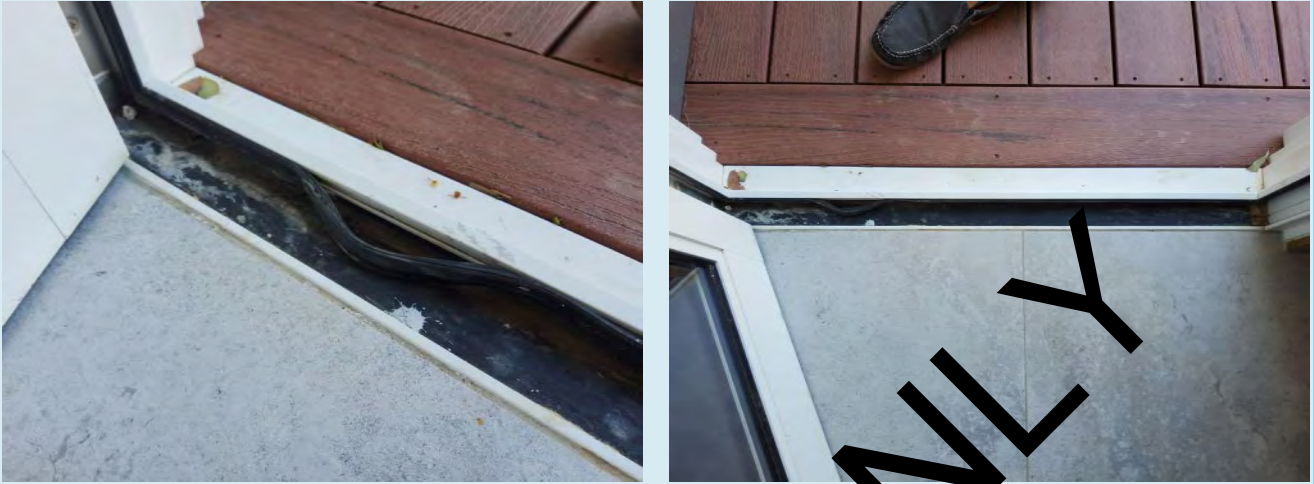
Laundry	
Minor and/or Major Defect	Doors
<b>Comments</b>	
Repair loose rubber seal. Clean off building debris/marks from door frame.

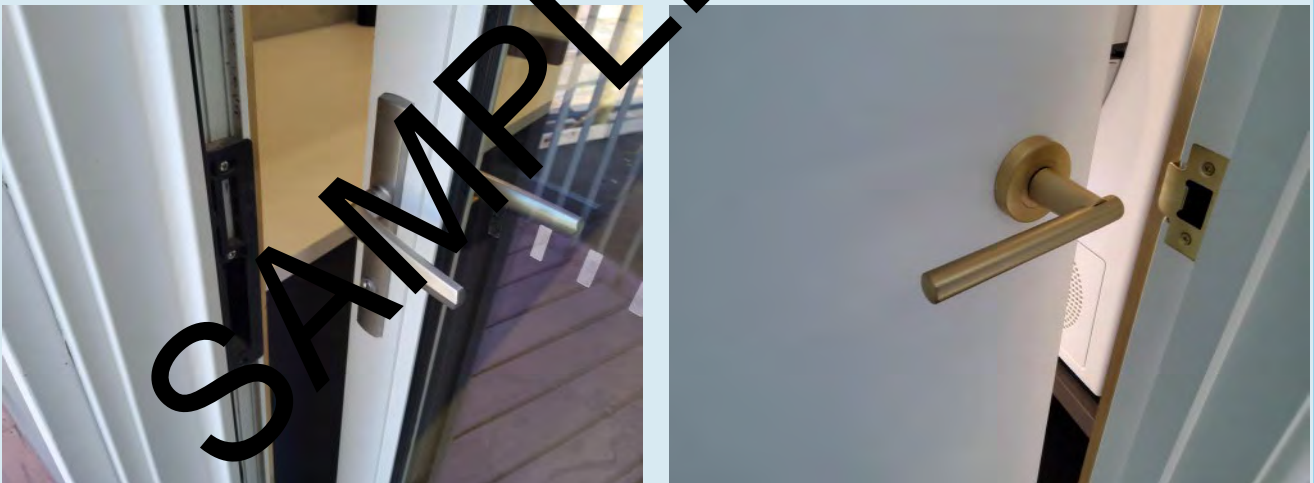
Laundry	
Minor and/or Major Defect	Doors
<b>Comments</b>	
Adjust the door striker plate to prevent door rattle, both doors.

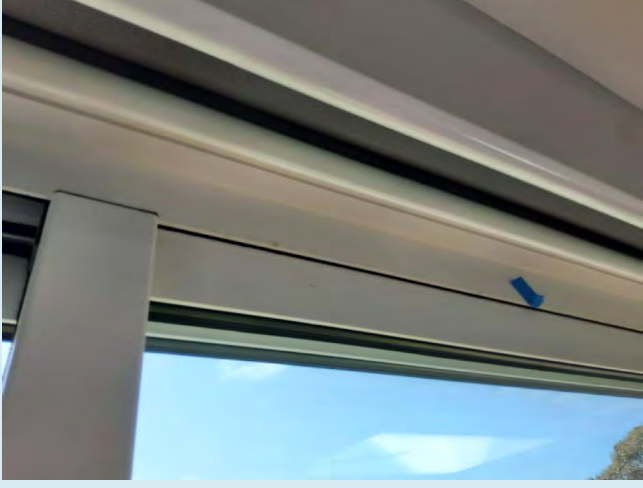
<b>Bedroom 1</b>	
<b>Minor and/or Major Defect</b>	<b>Windows</b>
<b>Comments</b>	
Touchup surface blemishes to window frame.

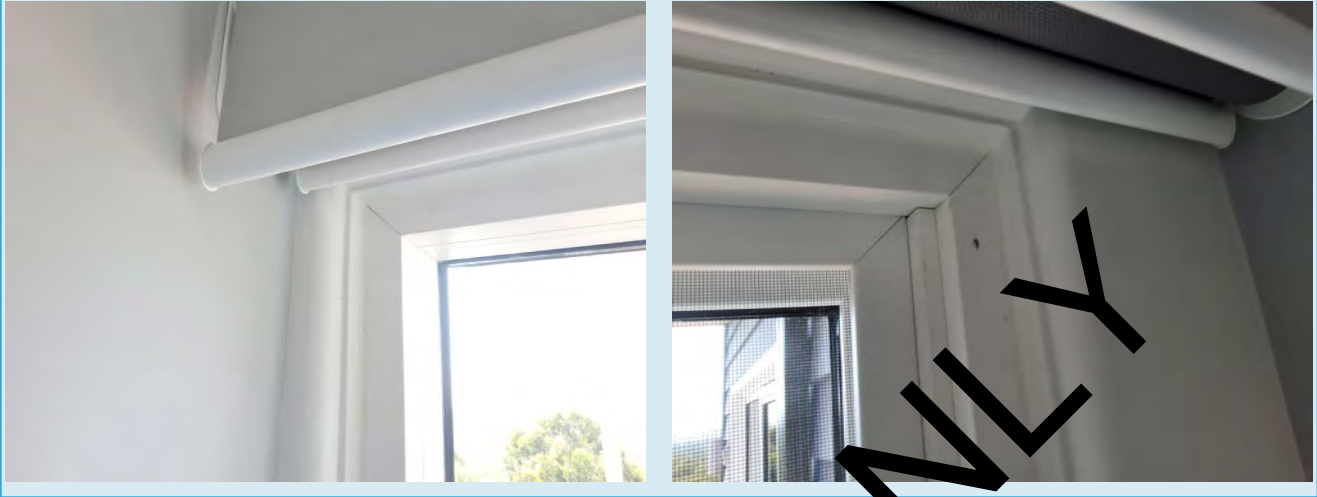
Bedroom 2	
Minor and/or Major Defect	Windows
<b>Comments</b>	
Fill shrinkage gaps at window mouldings and touchup paint.

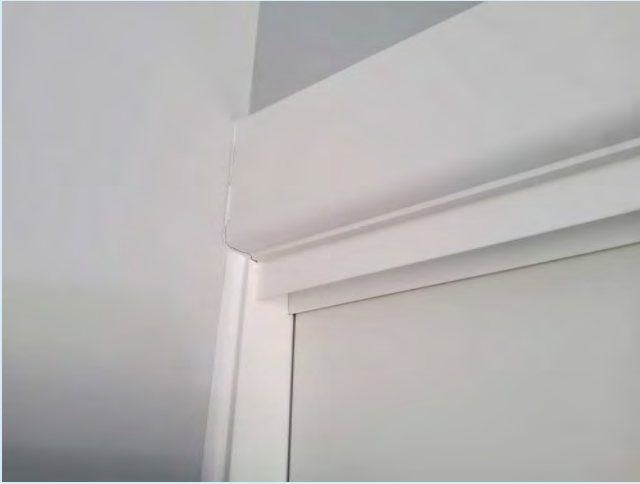
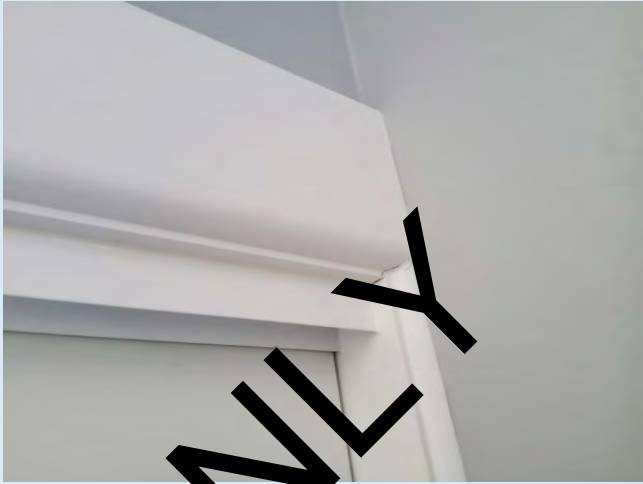
<b>Bedroom 3</b>	
<b>Minor and/or Major Defect</b>	<b>Doors</b>
<b>Comments</b>	
Touchup paint slight shrinkage gaps at robe architraves.

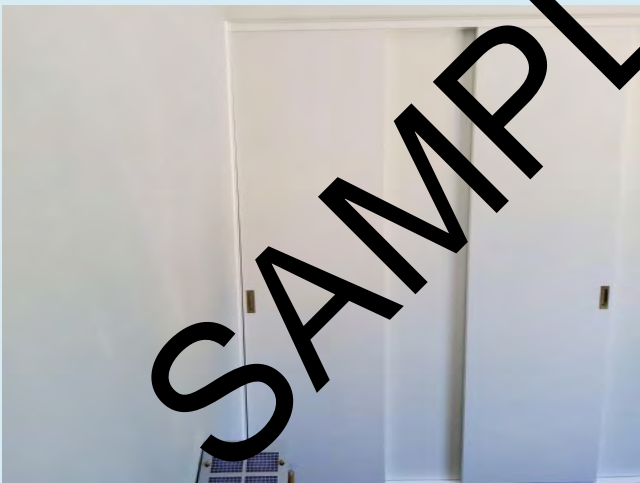
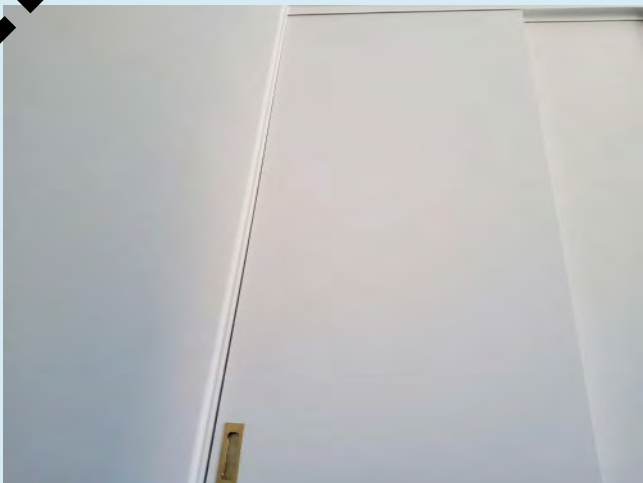
<b>Bedroom 3</b>	
<b>Minor and/or Major Defect</b>	<b>Robes</b>
<b>Comments</b>	
Adjust left robe sliding door to align with the doorjamb.

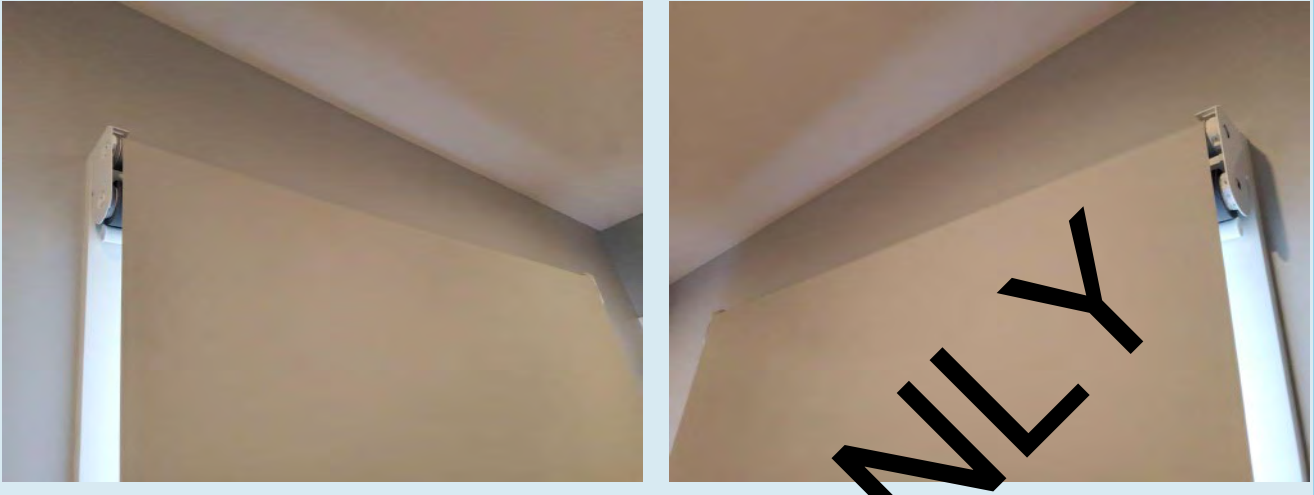
<b>Bedroom 4</b>	
<b>Minor and/or Major Defect</b>	<b>Windows</b>
<b>Comments</b>	
Fit chains or other device to control blinds.

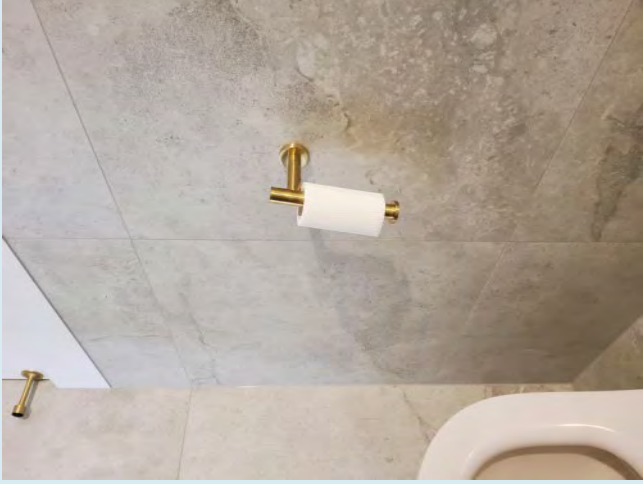
<b>Bathroom 1</b>	
<b>Minor and/or Major Defect</b>	<b>Toilet Roll Holder</b>
<b>Comments</b>	
Straighten and tighten toilet roll holder.

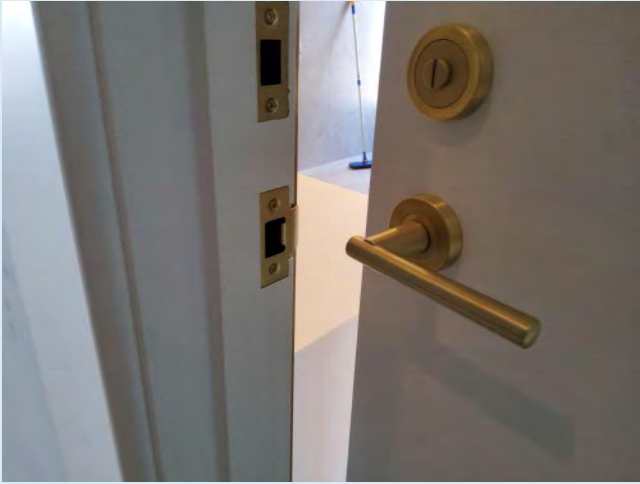
<b>Bathroom 2</b>	
<b>Minor and/or Major Defect</b>	<b>Doors</b>
<b>Comments</b>	
Adjust the door striker plate to prevent door rattle.

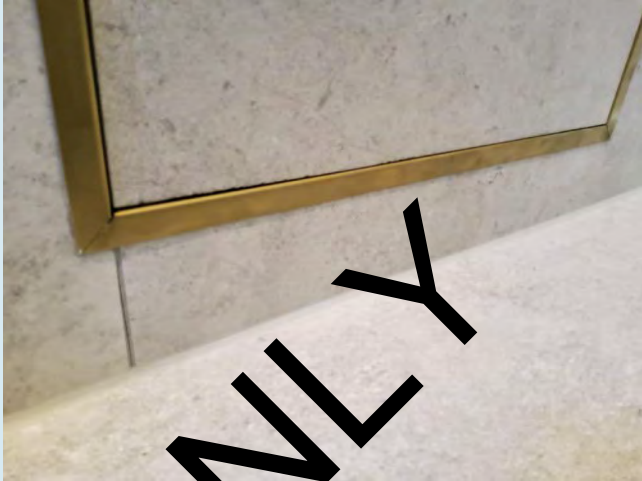
<b>Ensuite 1</b>	
<b>Minor and/or Major Defect</b>	<b>Cabinets</b>
<b>Comments</b>	
Adjust the tiled cabinet doors/drawers so there are consistent margins, and surfaces align. Lower edge was scraping the frame.

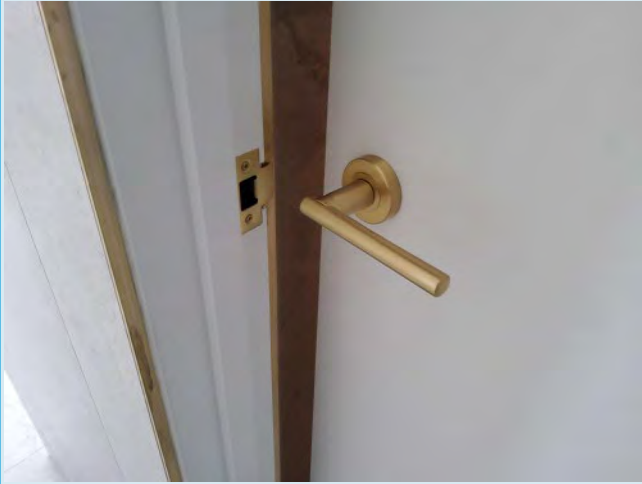
Ensuite 1	
Minor and/or Major Defect	Doors
<b>Comments</b>	
Adjust the toilet door striker plate to prevent door rattle.

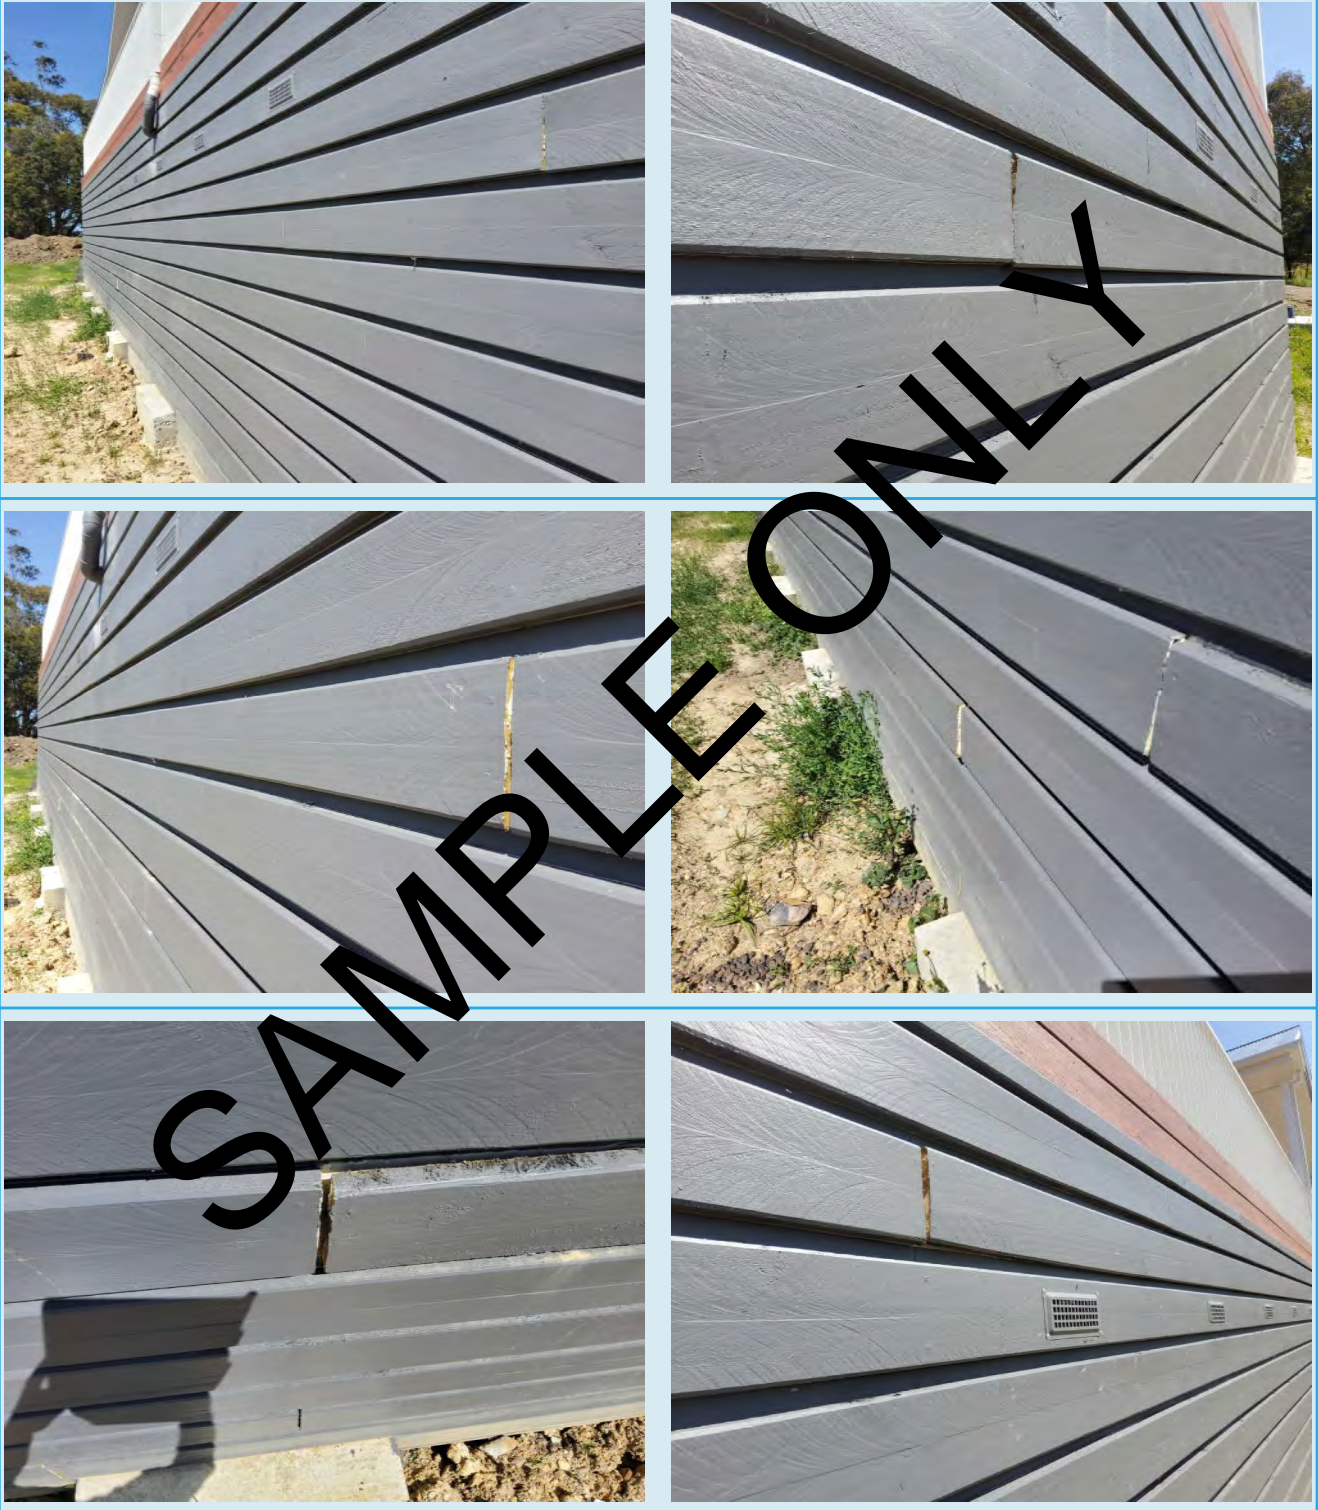
Timber boards around the subfloor area have shrinkage gaps between boards, and some twisting movement, and should be refixed, gaps filled and touchup paint to a consistent finish.

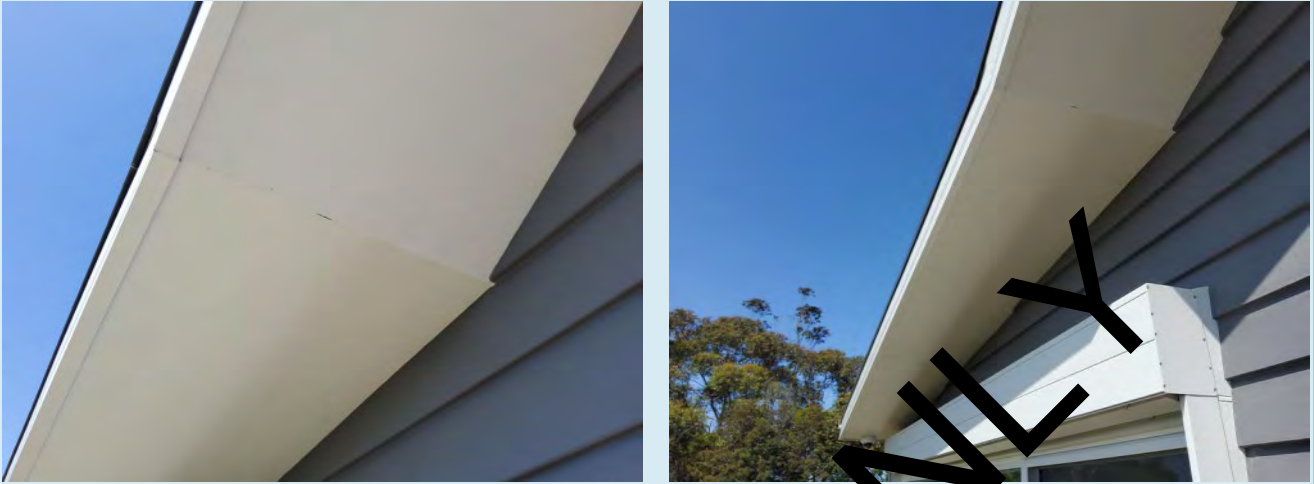
External > Exterior	
Minor and/or Major Defect	Fascia, Eaves, Bargeboards
<b>Comments</b>	
Touchup paint soffit outside main bedroom.

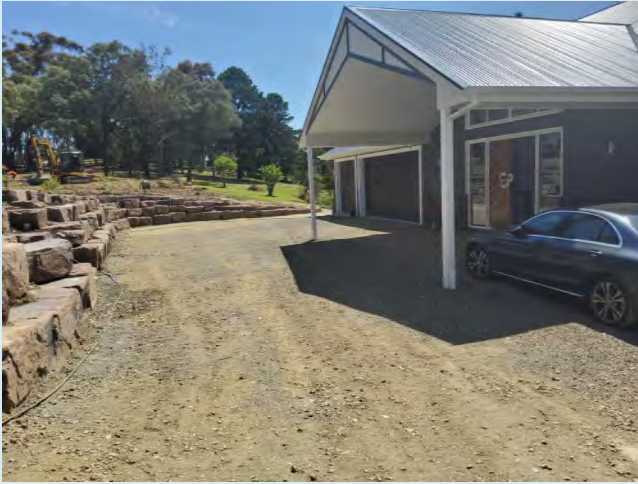
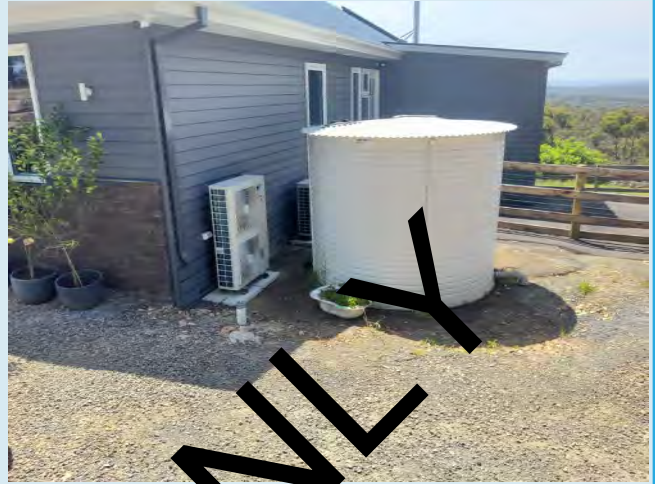
Driveway and paths finished hard surface not yet built.

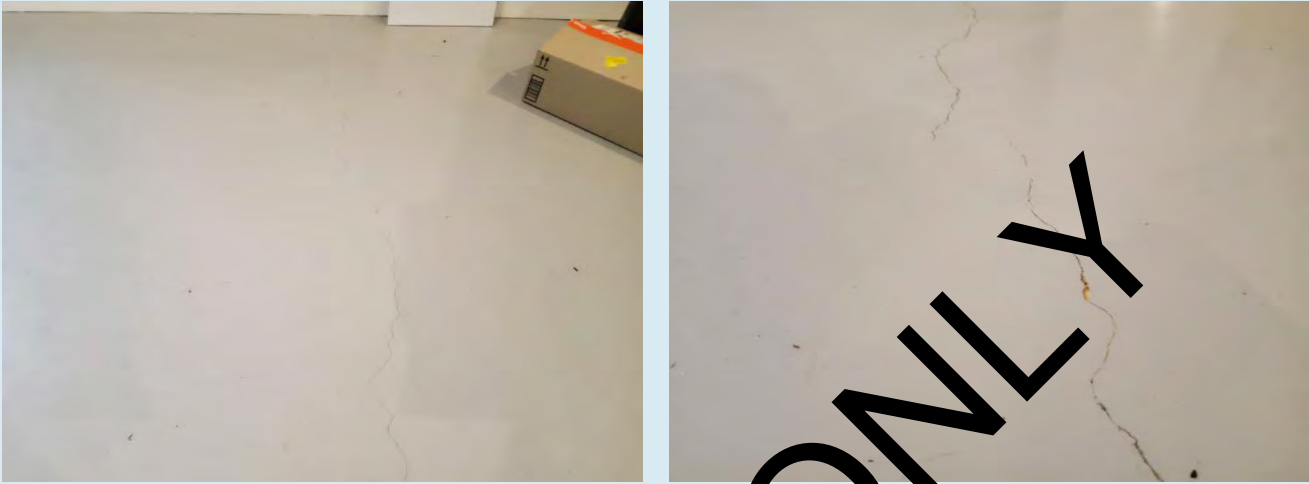
External > Exterior	
Minor and/or Major Defect	Garage/Car Port
<b>Comments</b>	
<p>Very slight crack (Category 1 - less than 1mm) noted.  As per VBA Guide to Standards and Tolerances, "Cracks to slabs are to be monitored for a period of 12 months. At the end of the monitoring period, cracks are defective if they are greater than category 2 (more than 2mm width) and attributed to the actions of the builder."</p>

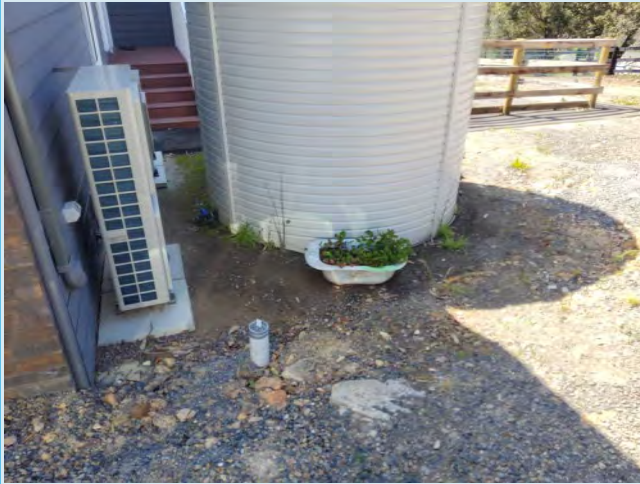
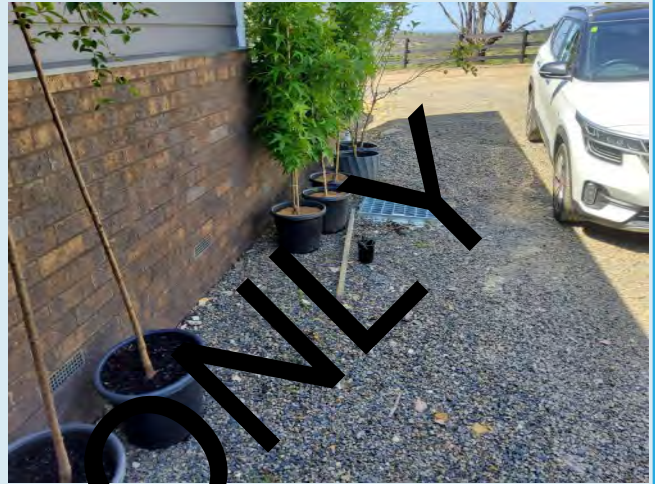
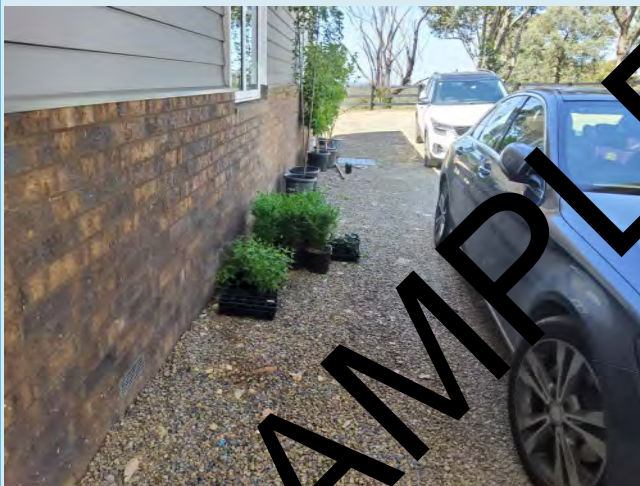
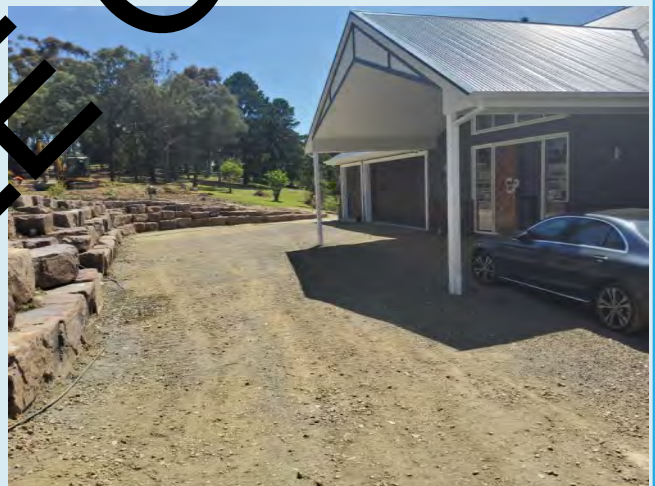
Site drainage along the higher (western) side of the house appeared to be inadequate, as there was significant areas of damp ground below the house, especially alongside the west brick wall. Damp subfloor conditions must be prevented in accordance with BCA requirements. Recommend a structural engineer specify site drainage (suitable for the soil type and footings detail). Site drainage should be provided by the builder / drainage contractor, to ensure that the structural integrity of the house and footings is maintained in the long-term.

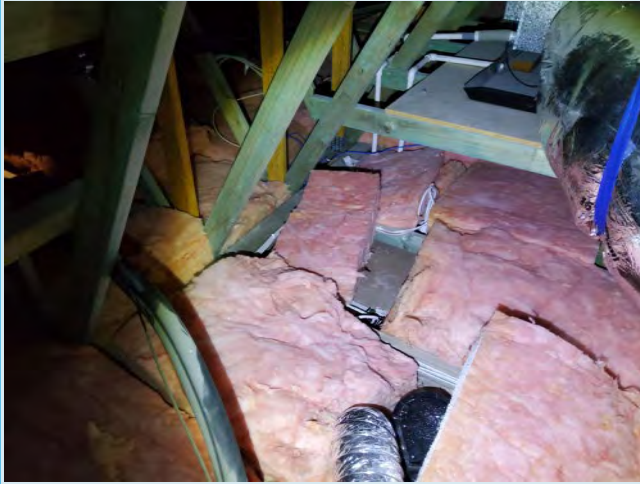
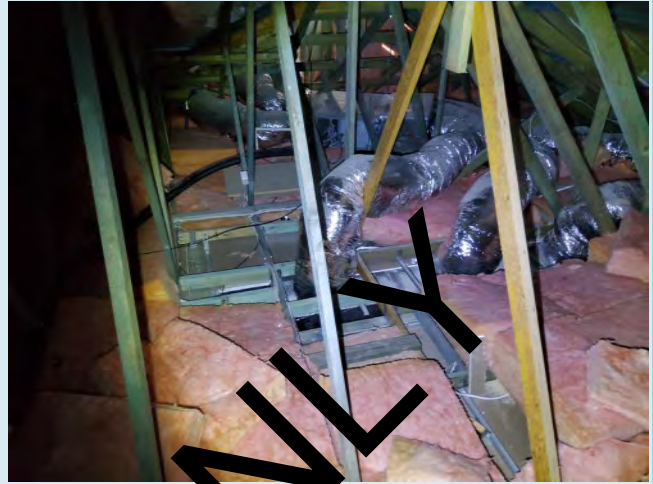
External > Roof Areas	
Minor and/or Major Defect	Roof Space
<b>Comments</b>	
Replace insulation batts where some have been moved to comply with BCA energy efficiency requirements.

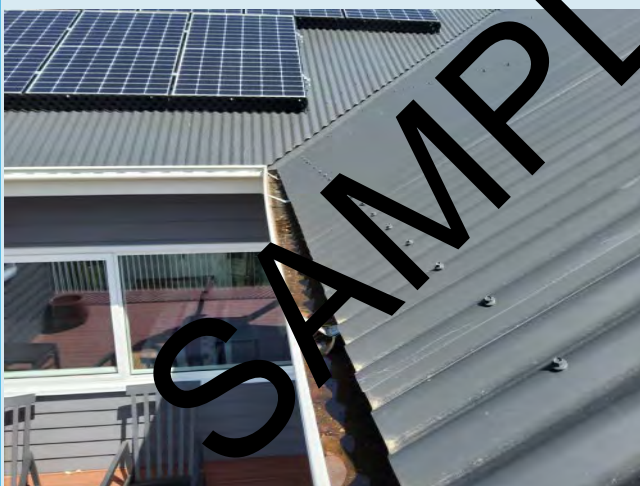
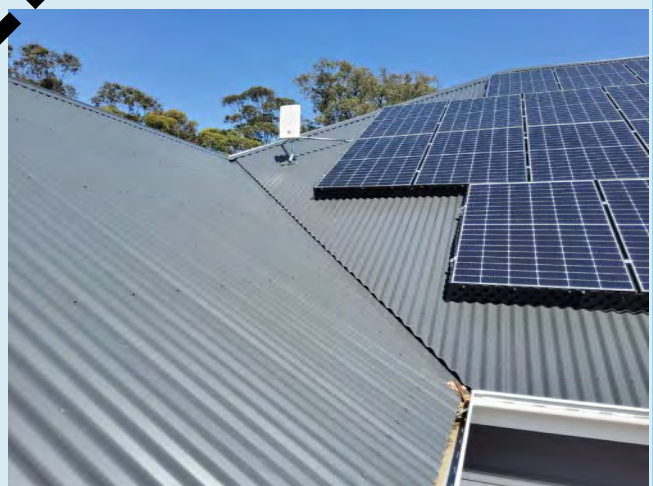
External > Roof Areas	
Minor and/or Major Defect	Gutters
<b>Comments</b>	
Water was pooling in the gutter on the south side of outdoor covered area, more than 10mm water pooling is defective. Repair gutter grading to ensure water drains to the downpipe.

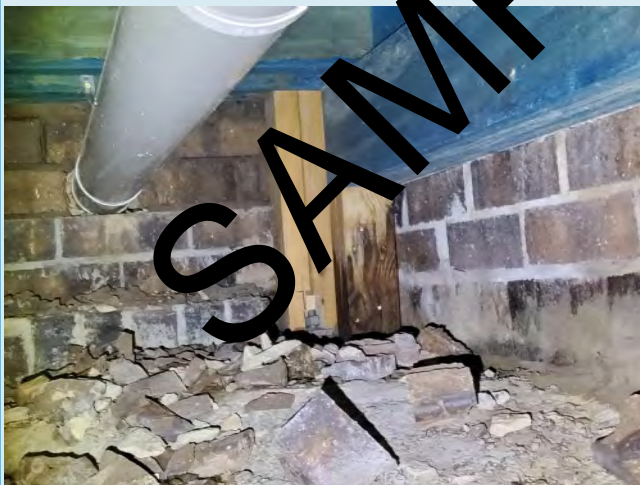
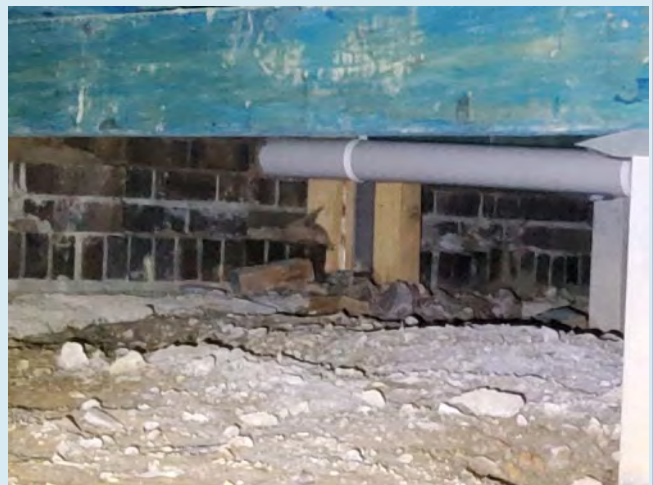
Timber supports in two places alongside the front brick wall were in ground contact, and wet condition. This is conducive to termites and fungal decay, and can allow termites concealed pathways from the ground into the house. Replace timber supports with durable materials and provide termite protection in accordance with Australian standard AS3660.1.

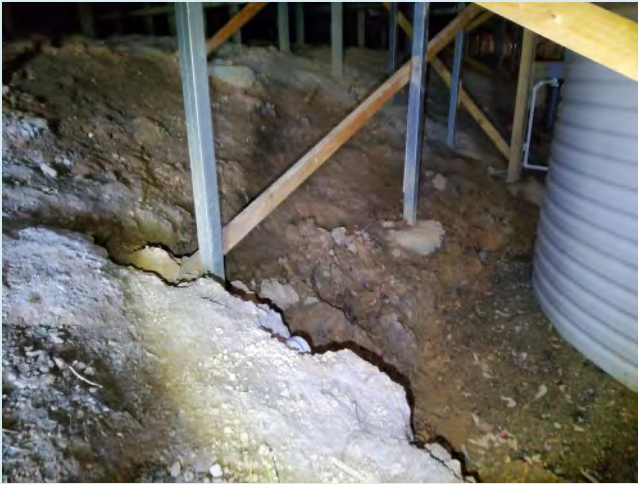
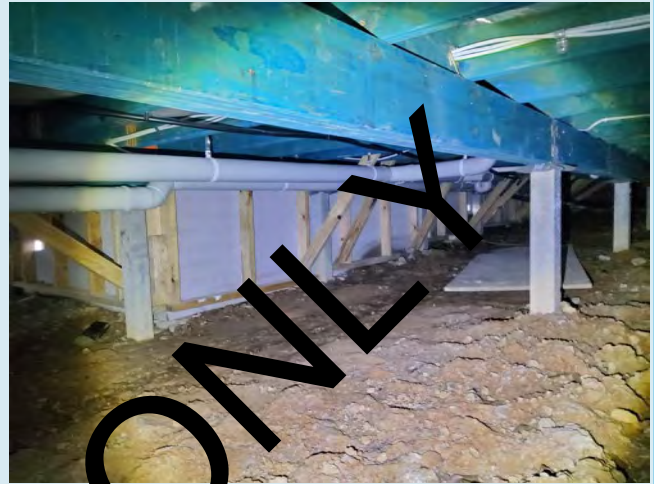
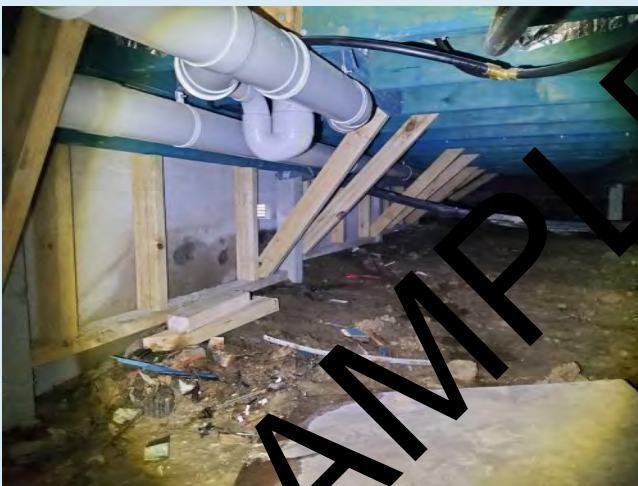
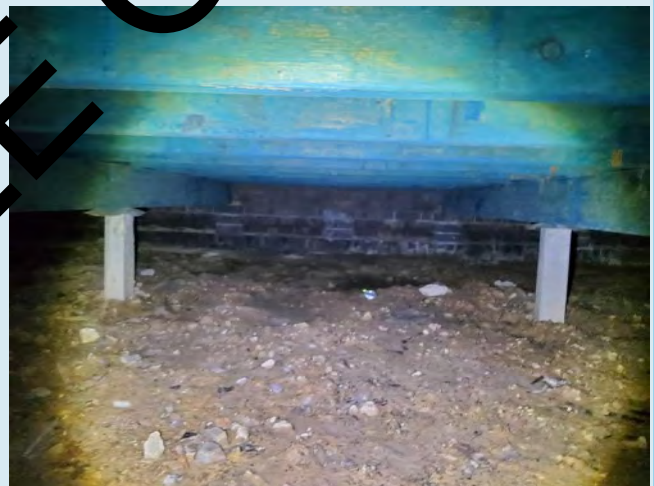
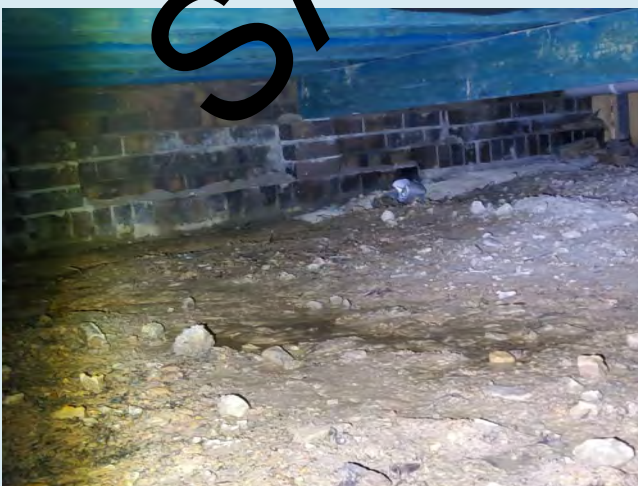
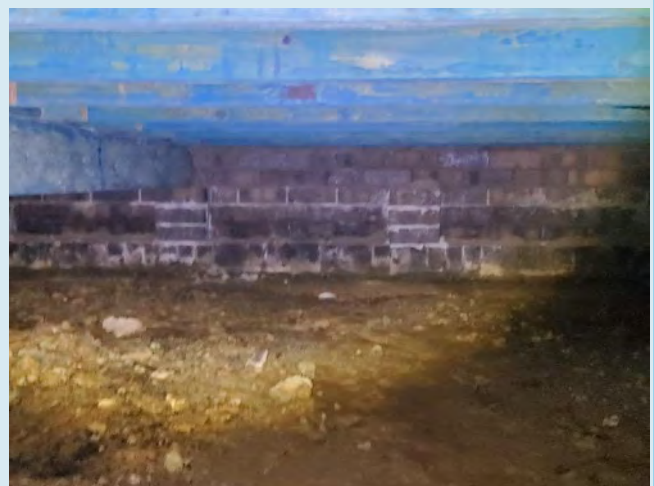
Subfloor ventilation appeared adequate, however there was significant areas of damp ground below the house, especially alongside the west brick wall (see Site Drainage comment in the external areas section of report). Damp subfloor conditions must be prevented in accordance with BCA requirements to ensure that the structural integrity of the house stumps and footings is maintained in the long-term. Recommend a structural engineer specify site drainage (suitable for the soil type and footings detail). Site drainage should be provided by the builder / drainage contractor to prevent damp ground conditions below the house.

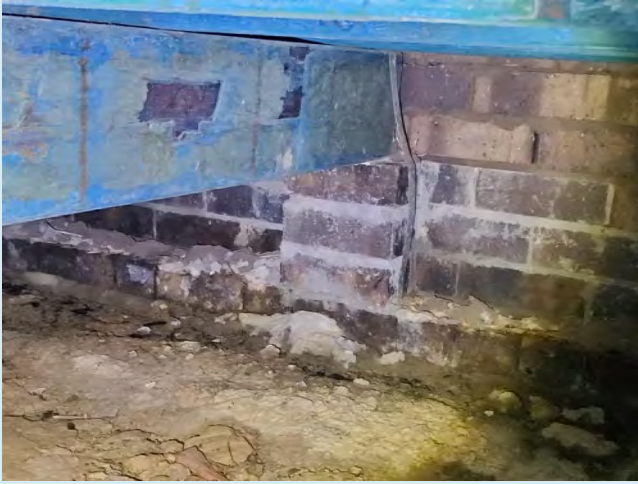
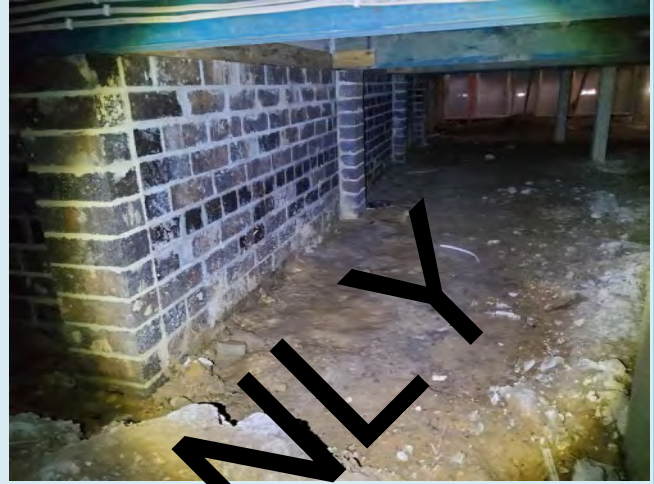
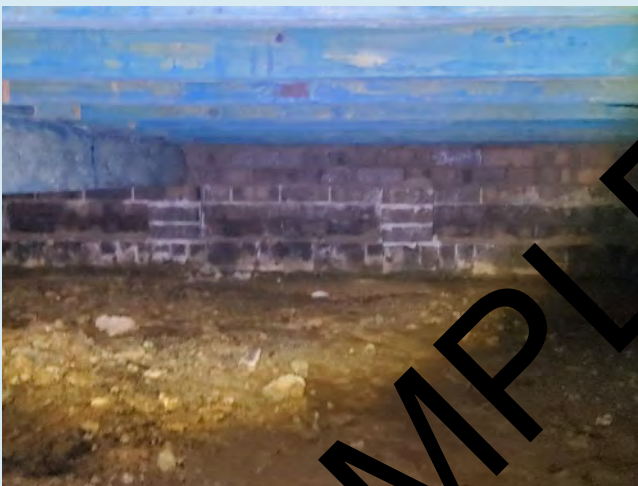
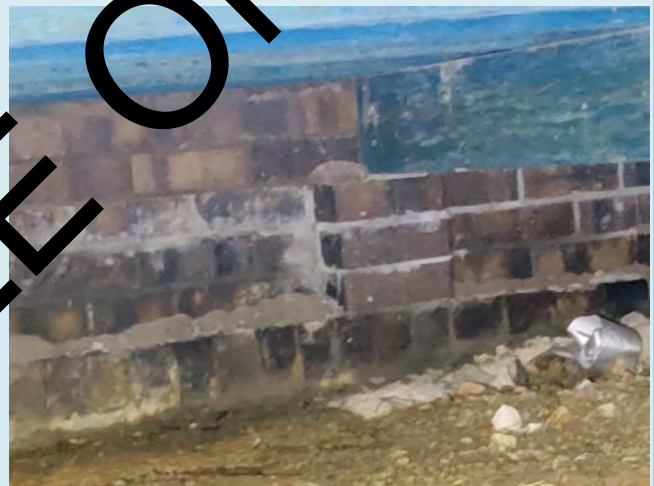
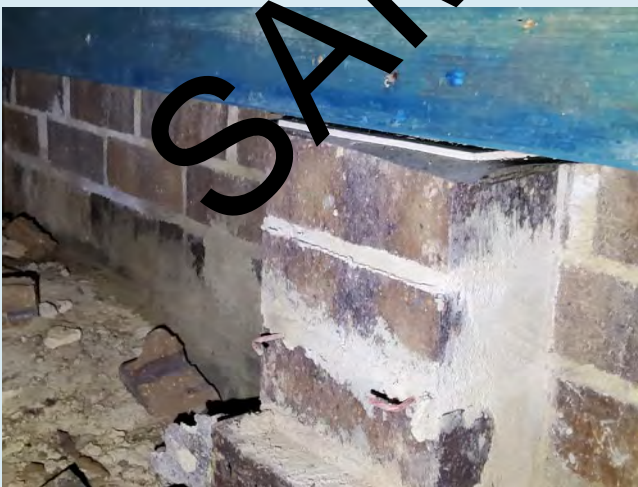
No damp proof membrane was fitted between some brick engaged piers and timber bearers.  
Damp proof membrane should be installed where missing to prevent damp deterioration to timber beams.
